**Temporary Works
forum**

TW21.044 (17.3.21)

Summary of a report of the failure of falsework at the Birling Road Overbridge, Kent 1971

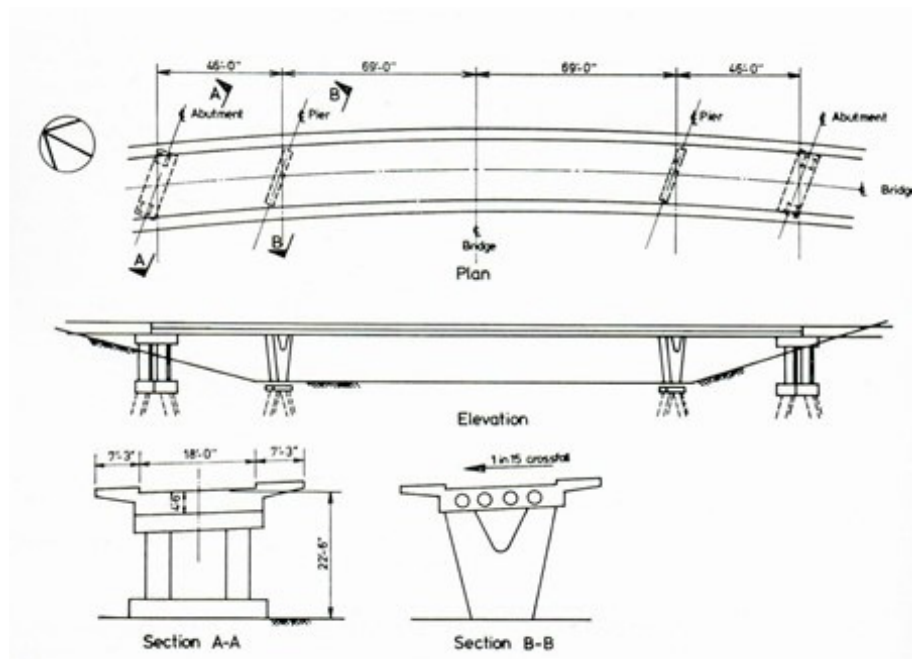
Figure 1 – Sketch of the bridge

The Birling Road Overbridge was a post-tensioned concrete bridge, consisting of three spans. The approach spans were of about 46 ft and the main span of 138 ft, all lying in a roughly north-south direction. The bridge was curved on plan and had a crossfall of one in fifteen. The underside of the deck was approximately 18 ft above ground level. The deck was 4 ft 6 in deep and contained void formers. A sketch of the bridge is in Figure 1.

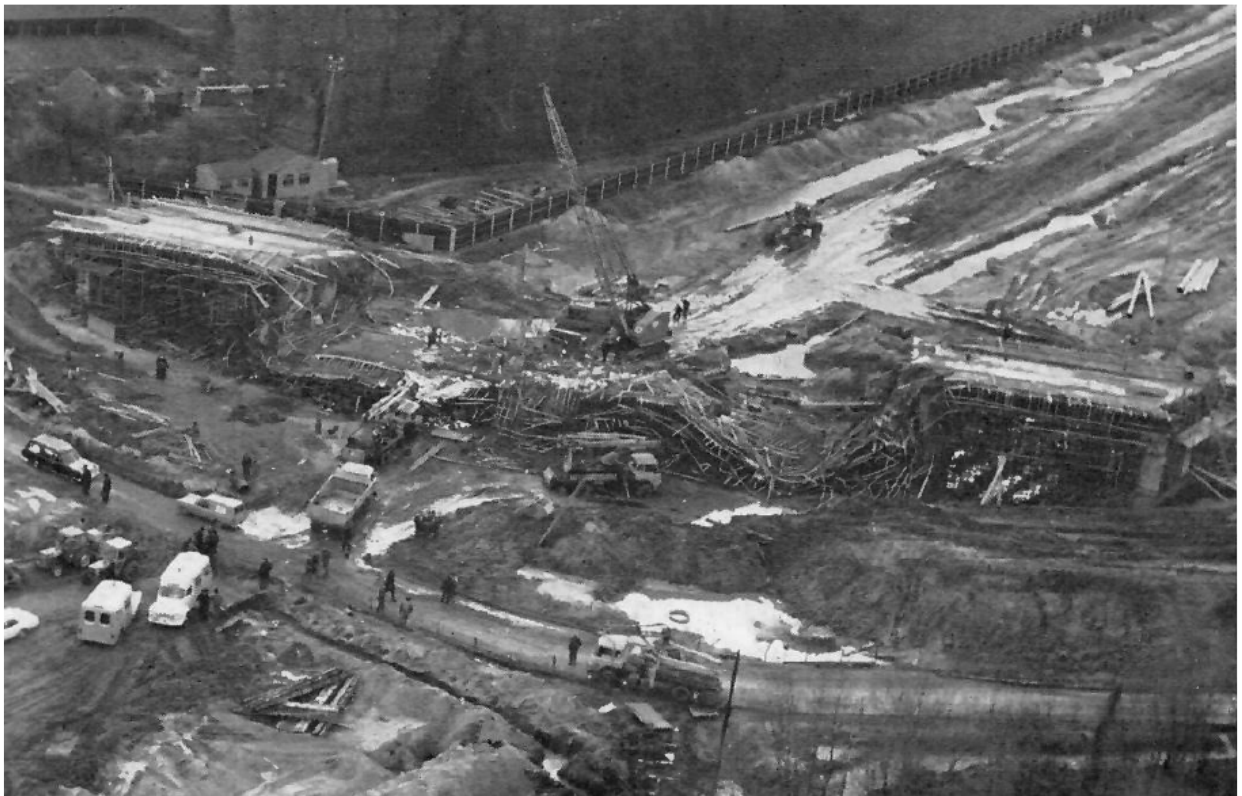
The main span collapsed entirely but the side spans remained more or less intact.

From examination of the wreckage of the main span it was clear that the majority of standards had all failed in one direction and that the mode of failure was in a single curve from top to bottom. This suggested that the actual effective length of the standards in the collapse condition was not related to the distance between intermediate horizontal members. There was very little evidence of contraflexure between these members, i.e. between nodes.

Aerial view of the devastation at Birling Road Overbridge
Ditton, Kent, March 1971 (p17)

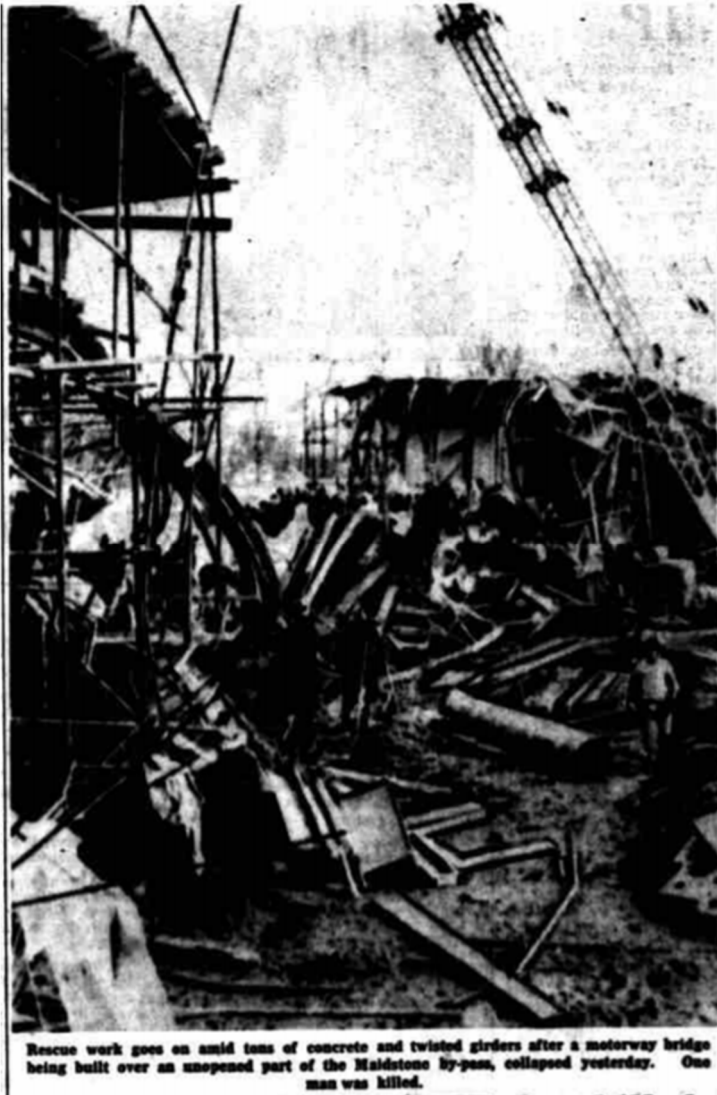
Rescue work goes on amid tons of concrete and twisted girders after a motorway bridge being built over an unopened part of the Maidstone by-pass, collapsed yesterday. One man was killed.
